**STATE OF VERMONT
PUBLIC UTILITY COMMISSION**

Notice of Probable Violations by Vermont Gas)
Systems, Inc. for certain aspects of the) Case No. 18-0395-PET
construction of the Addison Natural Gas)
Project)

RESPONSE OF VERMONT GAS SYSTEMS, INC. TO DPS FEBRUARY 16, 2018 NOPV

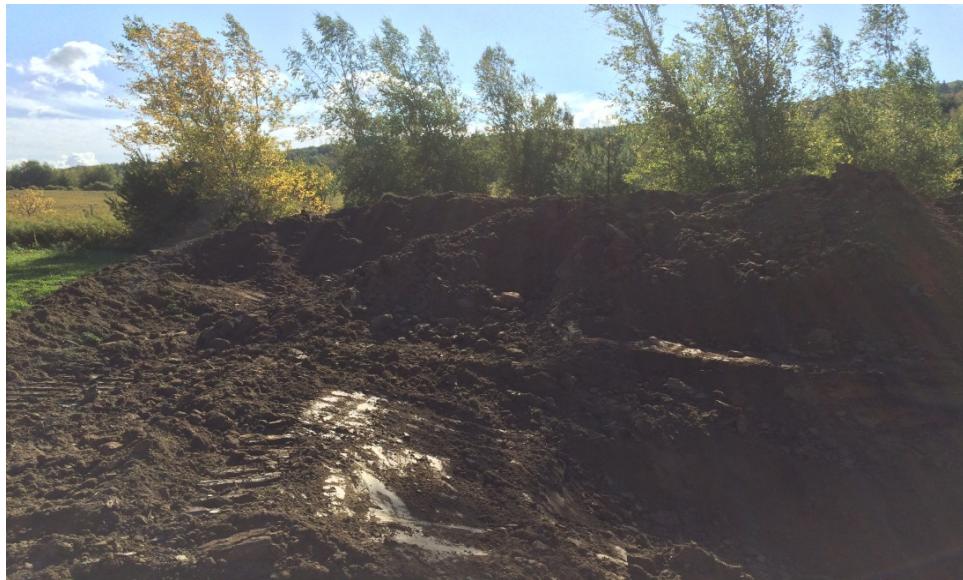
The Enduro Pipeline Services caliper inspection detected a 1.7% deformation in the pipe at the 4:00/4:30 location on the pipe at station 565+85, indicating a possible dent in the pipe. Pictures below show no rocks were detected around the pipe or anywhere in the excavation. Pictures also show no indication of a dent found due to construction while inspecting the pipe.

Excavation dirt pile with clumps of clay and no rocks.

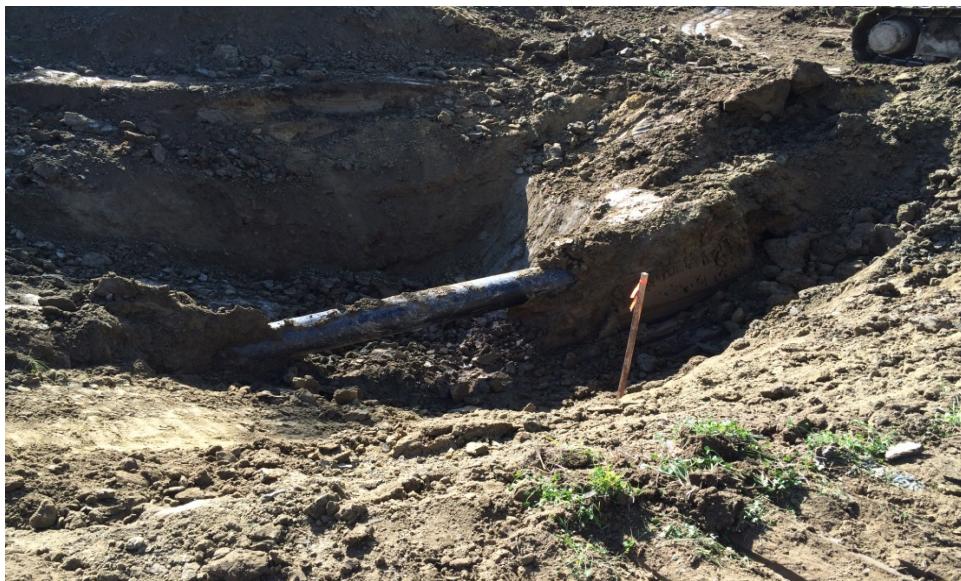
Exposed pipe section at station 565+85. Moved stake into area to show location of possible dent.

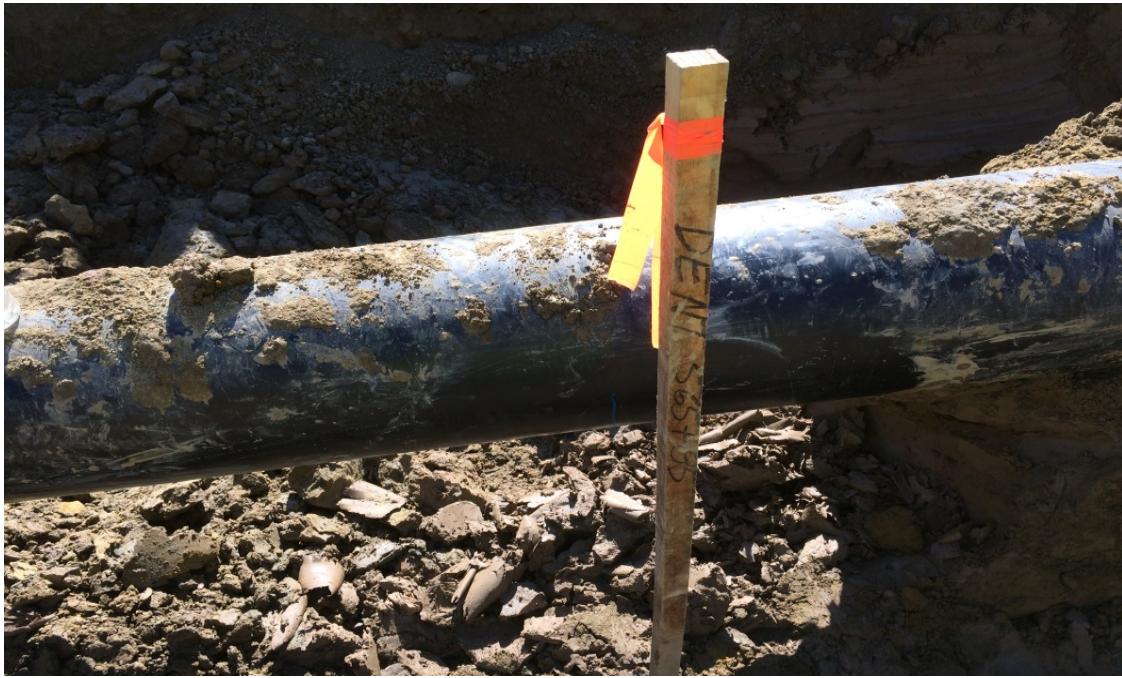
ANGP Pipeline Anomaly Dig, @ station 565+85

No dent or coating damage spotted at station 565+85 after cleaning the pipe and thoroughly inspecting the pipe by hand. Checked the pipe several feet upstream and downstream of station number.

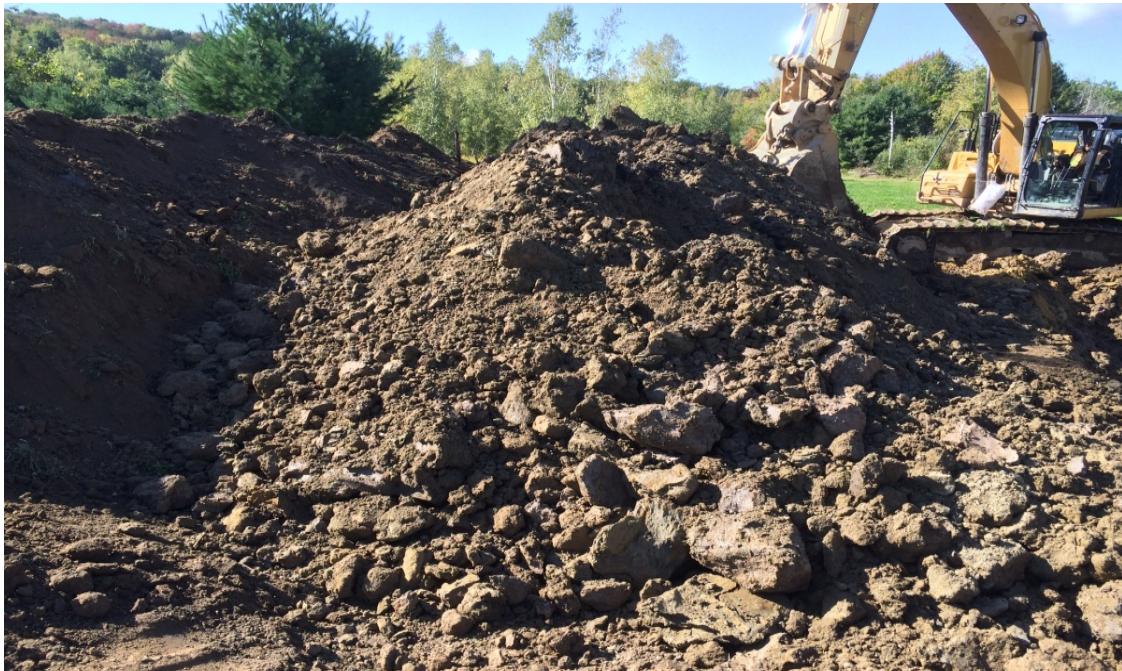
Excavation dirt pile with clumps of clay and no rocks. Expanded excavation to locate weld 0193.

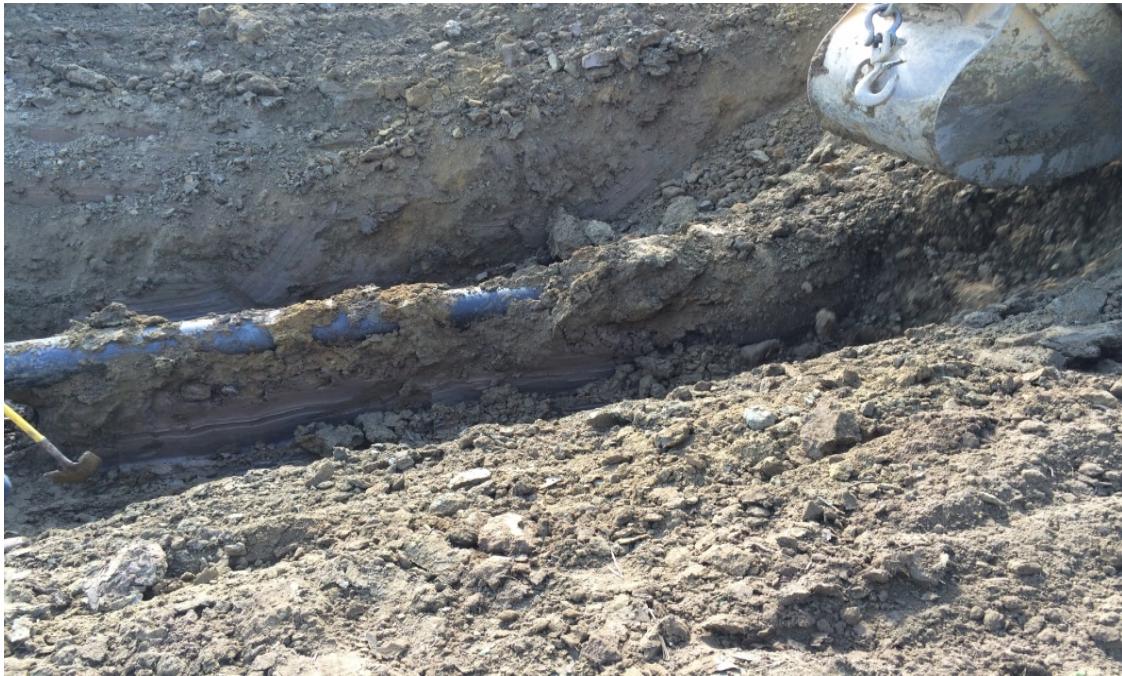
ANGP Pipeline Anomaly Dig, @ station 565+85

Exposing more pipe to weld 0193. No rocks detected just clumps of clay and clay topsoil mix.

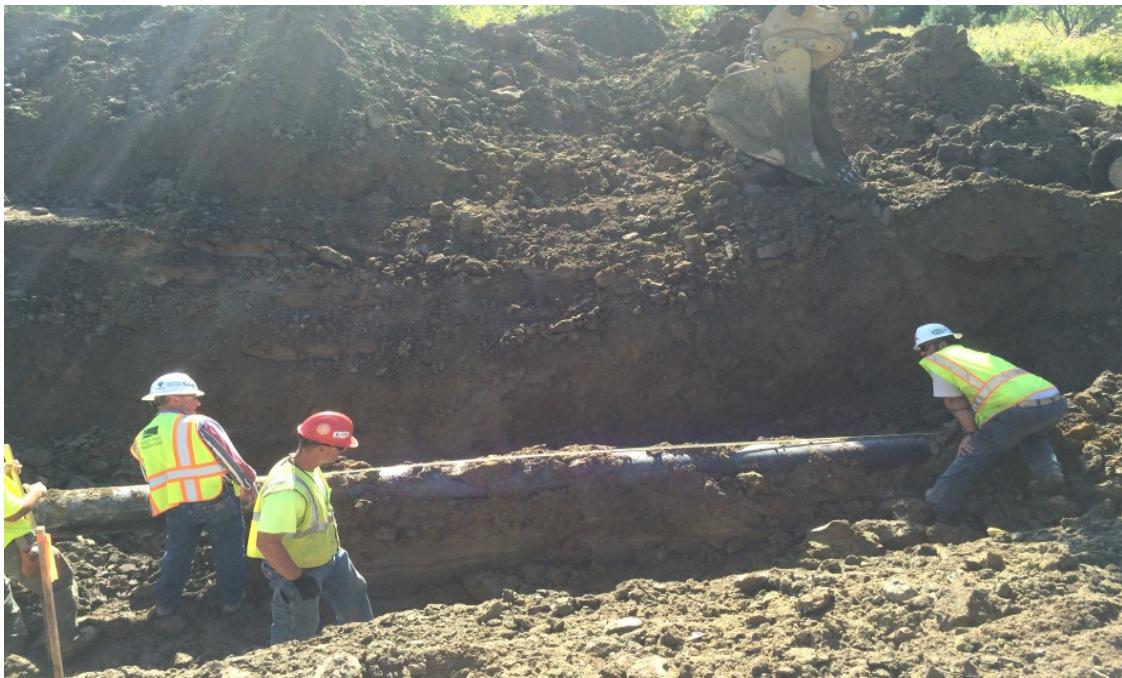
Measurement of 17' from weld 0193 to possible dent to confirm location.

Confirmation measurement came to the same location from the first location observed based point set by survey. No dent detected due to a construction condition on any part of the pipe upstream or downstream of station 565+85. Re-inspected the pipe by hand several feet upstream and down stream of station 565+85 to feel for any damage. Also inspected pipe for damage in the entire section exposed. No coating damage detected or indication of a dent due to construction in the section of pipe exposed.

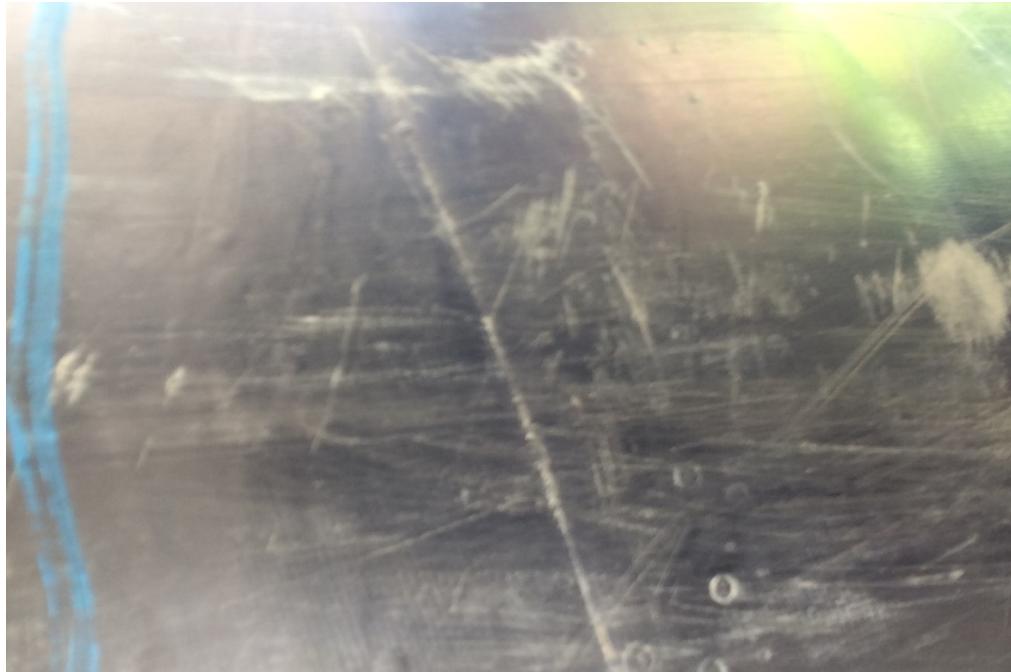
Close up picture of station 565+85 at the 4:00/4:30 location. No coating damage or dent detected

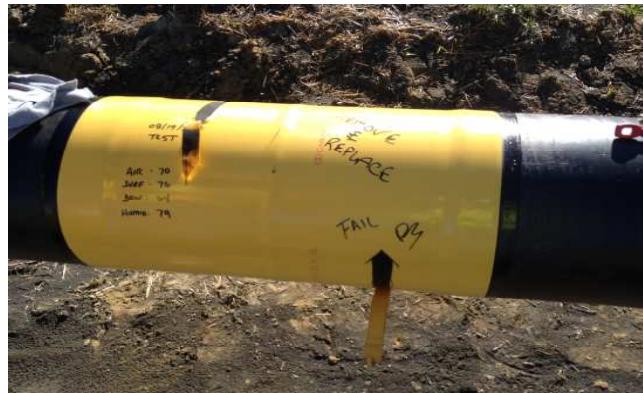
Figure 1: Canusa K-60/L, QA# 13-B-319 SL

The testing and results obtained described above indicate that the Sleeve's performance was normal, acceptable and the peel testing in the field was conducted at a peel failure mode transition temperature (temperature differential). Both results would be considered a PASS.
