**STATE OF VERMONT
PUBLIC UTILITY COMMISSION**

Notice of Probable Violations by Vermont Gas)
Systems, Inc. for certain aspects of the) Case No. 18-0395-PET
construction of the Addison Natural Gas)
Project)

RESPONSE OF VERMONT GAS SYSTEMS, INC. TO DPS FEBRUARY 16, 2018 NOPV

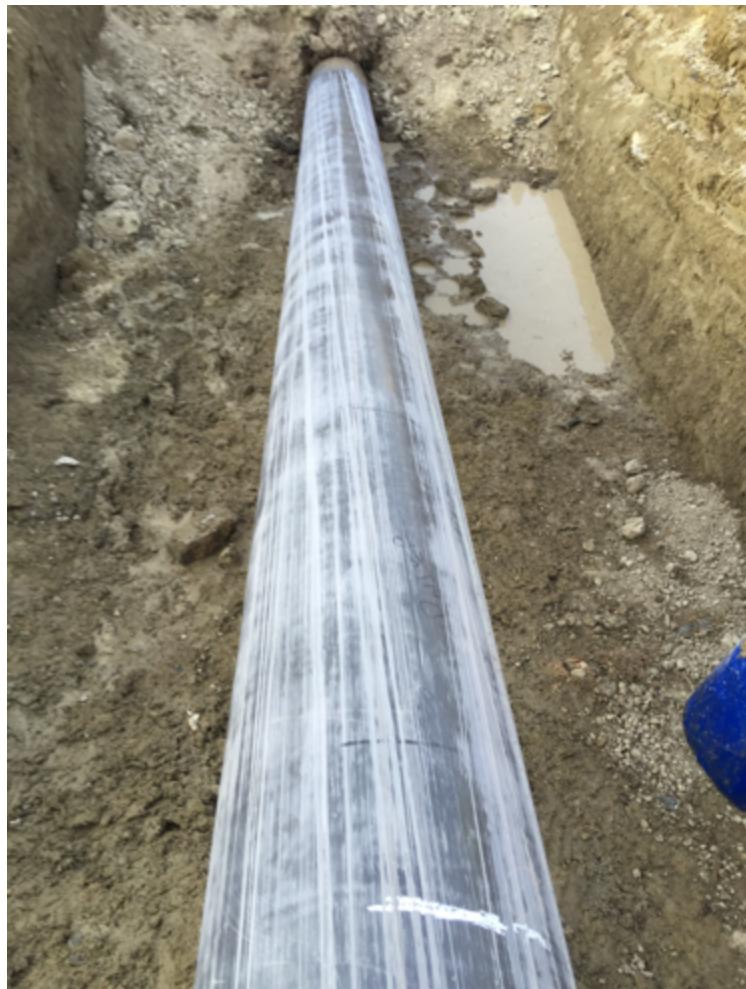
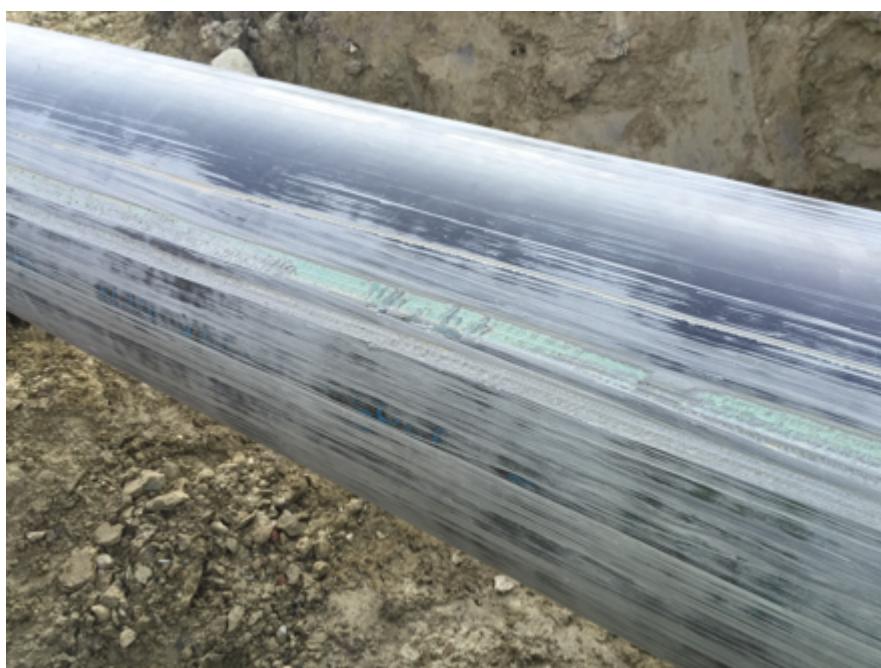
Michels Pipeline Construction completed the HDD of the Monkton Swamp on August 6, 2016. During the initial inspection of the pipe and a weld, coating damage down to metal was found, along with some damage to the steel pipe. Additional pipe was pulled through the borehole to locate where the damage ended. Approximately 158 feet of additional pipe was pulled. On August 10, 2016 an approximately 16-foot section of pipe was inspected. Visual inspection of the pipe showed no damage to the steel pipe or coating damage down to bare metal. There were scratches and scrapes in the Abrasive Resistant Overlay (ARO), some down to the FBE pipe coating. This section of pipe was jeeped and did not indicate any holidays in the coating. The jeep was checked using a known anomaly on an adjacent section of pipe and did alert, indicating a holiday. The HDD was accepted. Present for the final inspection were Christopher LeForce (VGS Project Engineering Manager), Mike Reagan (ANGP Construction Manager), Darrell Crandell (ANGP Chief Inspector), Bob Spinette (Michels HDD Superintendent), Carl Bubolz (Michels Construction Superintendent), and John McCauley (Vermont State Inspector).

The acceptance criteria for an HDD was met in this instance. After finding damage to the steel pipe and coating during the initial inspection of 15 feet of consecutive pipe and a weld, additional pipe was pulled through as the plan indicates to do. The damage to the steel pipe and coating subsided as more pipe was pulled through. A new visual inspection of 15 feet of consecutive pipe was completed which indicated damage to the ARO. This same section of pipe that was inspected using a jeeping tool and no holidays were found on the section.

The "HDD Inspector's QA Checklist" for the Monkton Swamp HDD is attached for reference. Also included below are pictures of the final section of pipe inspected.
